Manhole Inspection Summary

Manhole # S19MM_009MH

Location Address: **2112 PULASKI-SMALLWOOD** Cross Street: **WINDSOR AVE**

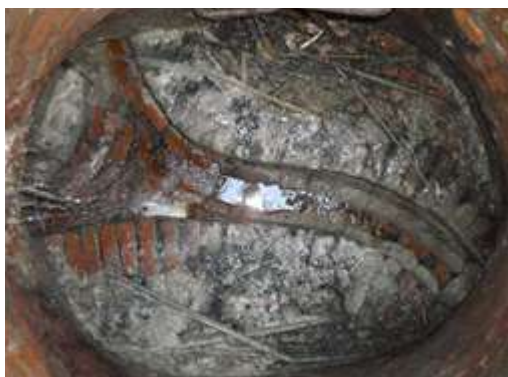
Top View

THE OUT IS IN THE TOP LEFT CORNER OF THE PICTURE, NOTE DROP IN ON LEFT SIDE OF FRAME AS

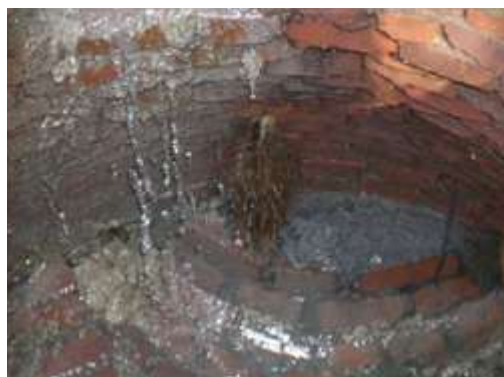
Defect 3

Barrel Material: **Brick** ☐ Parged
Shape: **Circular** Diameter: **46** (in.) Length: (in.)
Condition: ☐ Sound ☐ Cracked ☒ **Root Intrusion** ☐ Loose Brick ☐ Deteriorated
Infiltration: ☒ None ☐ Joint ☐ Cracks ☐ Mortar ☐ Roots ☐ Wall

ROOT INTRUSION

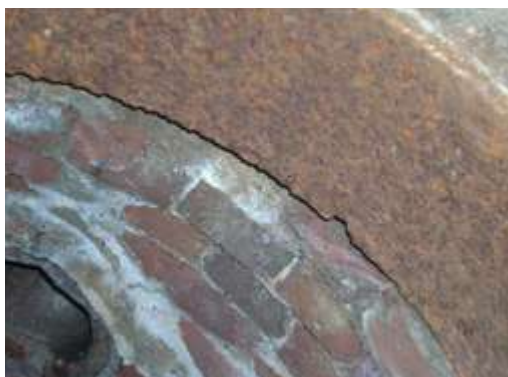
Defect 2

Chimney / Frame Adjustment ☒ Exists Material: **Brick** ☐ Parged Height: **3** (in.)
Condition: ☐ Sound ☐ Cracked ☐ Root Intrusion ☐ Loose Brick ☒ **Deteriorated**
Infiltration: ☒ None ☐ Joint ☐ Cracks ☐ Mortar ☐ Roots ☐ Wall

CHIMNEY DETERIORATION

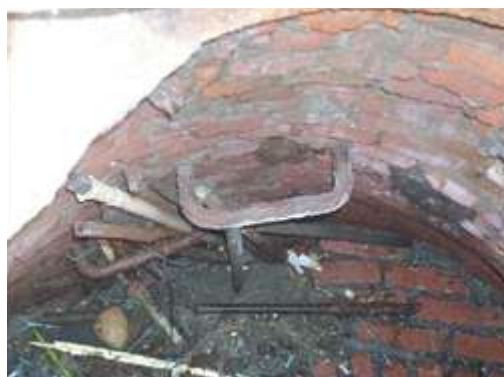
Defect 1

Steps Count: **2** Missing: **1** ☒ **Corroded**

MISSING AND CORRODED STEPS

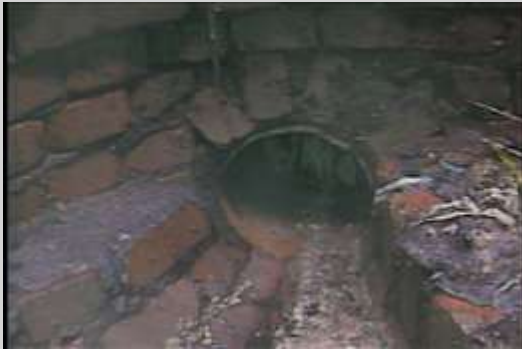
12 O'Clock Outflow

Pipe Height: **8.4** (in.) Rod and Bar (Angled)
Pipe Material: **Clay** ☐ Pipe Lined
Invert Depth: **6.66** (ft.) Flow Characteristics: **Slow**
Deposits: ☐ None ☐ Mud ☐ Sludge ☒ **Debris** ☐ Grease
Silt Depth: **1** (in.) Deposits Extent: **Light**
Infiltration: **None** Pipe Seal Cond: **Sound**

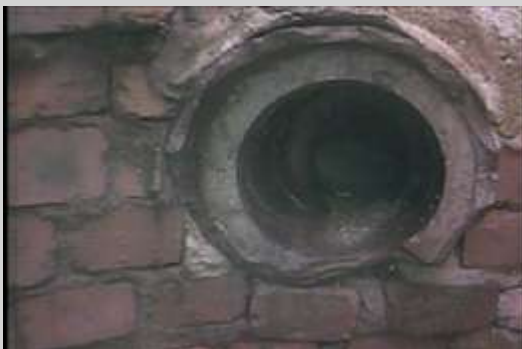
4 O'Clock Inflow

ROOT INTRUSION

Pipe Height: **8.4** (in.) Rod and Bar (Angled)
Pipe Material: **Clay** ☐ Pipe Lined
Invert Depth: **2.54** (ft.) Flow Characteristics: **Slow**
Deposits: ☐ None ☐ Mud ☐ Sludge ☒ **Debris** ☒ **Grease**
Silt Depth: **1** (in.) Deposits Extent: **Light**
Infiltration: **None** Pipe Seal Cond: **Broken**

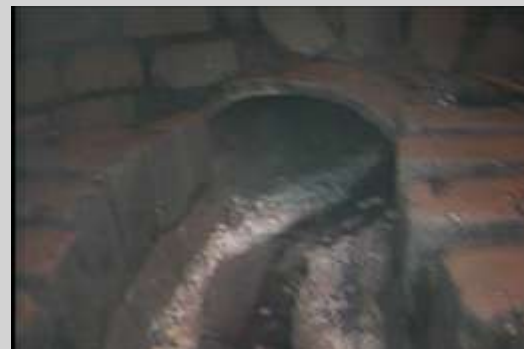
Drop In @ 4 O'Clock

ROOT INTRUSION

Drop: **Outside** Rod and Bar
Angled: **Yes** Reading: **5.41** (ft.)
Inv Depth: **6.41** (ft.)

Drop Condition: **Open**

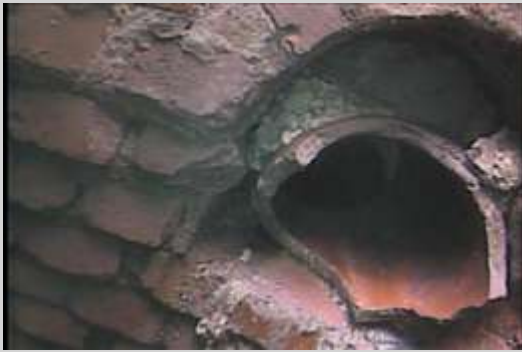
9 O'Clock Inflow

ROOT INTRUSION

Deposits: ☐ None ☐ Mud ☐ Sludge ☒ **Debris** ☒ **Grease**

Silt Depth: **6** (in.) Deposits Extent: **Heavy**

Infiltration: **Evidence** Pipe Seal Cond: **Broken**

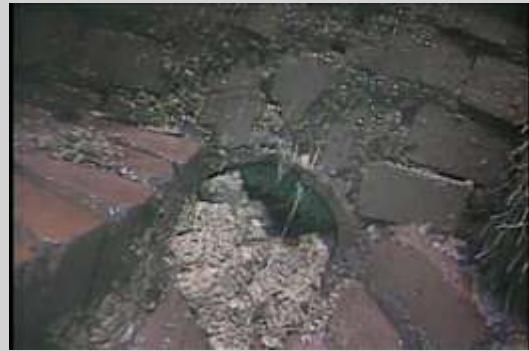
Drop In @ 9 O'Clock

ROOT INTRUSION

Drop: Outside	Rod and Bar
Angled: Yes	Reading: 5.47 (ft.)
	Inv Depth: 6.47 (ft.)
Drop Condition: Clogged
